Report to Council

Department: Community Services
Division: Parks and Facilities
Date: August 24, 2020
Prepared by: Doug Sweet, Director of Com. Services/Deputy CAO
Report Number: Parks and Facilities-2020-07
Subject: Essex Centre Sports Complex Structural Repairs
Number of Pages: 14

RE: SLAB HEAVING ISSUES WITHIN THE ESSEX ARENA COMPLEX.
Our Project No. 19-a160

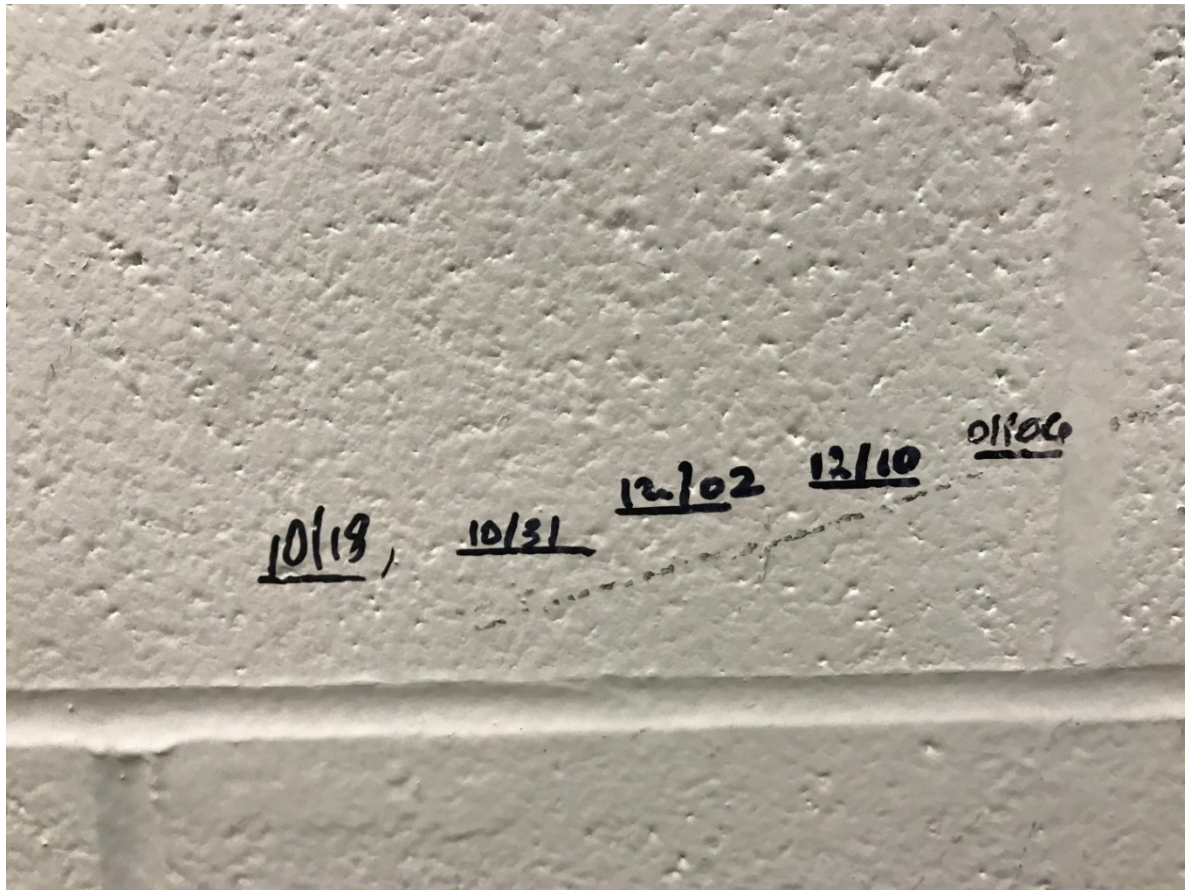
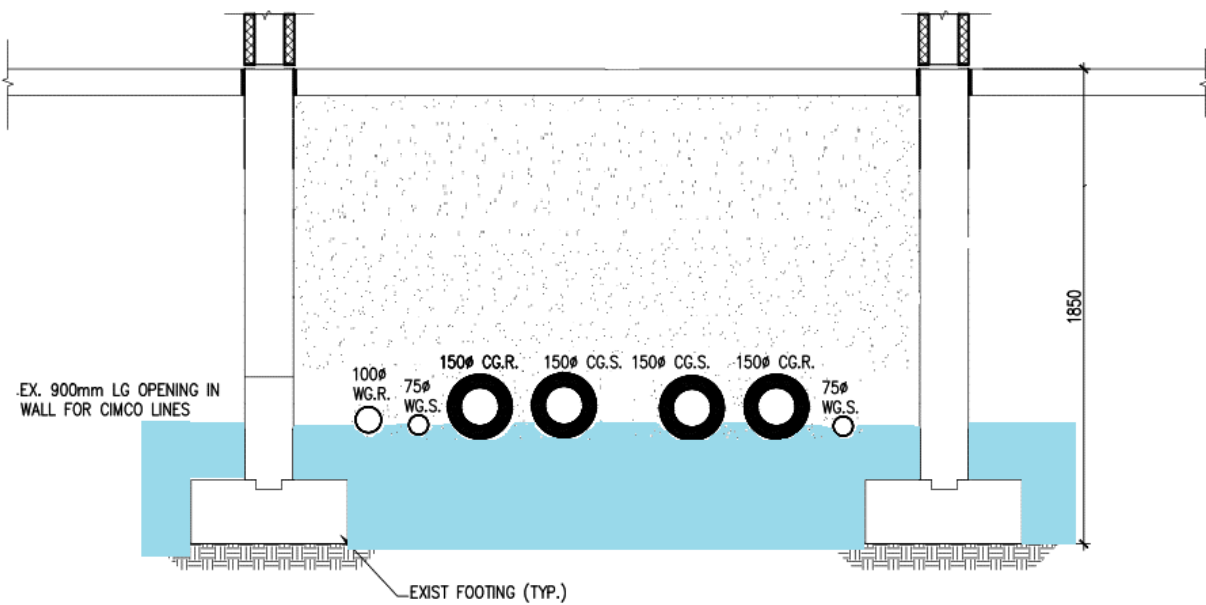
Appendix A – ECSC Heaving Benchmarking

In November of 2019, the Essex Centre Sports Complex staff started to notice the hallway in the back third of the Libro Rink (main rink) at the complex was starting to lift. The Manager of Parks and Facilities continued to monitor the area (see Appendix A) and as the area started to heave more the engineering firm of Haddad Morgan and Associates (who were involved in the construction of the facility) was contacted to investigate the cause of the heaving. As part of their investigation Haddad Morgan brought in CT Soils (Geotech Engineers) to core drill a number of holes in various locations at a depth of 1.5 meters. Through these soil tests, it was determined ground water was entering the sub soils and the underside of the glycol lines were saturated (see Appendix B). In addition to the hallway it was identified the heaving expanded to include the mechanical room, cracking on the stairwell to the Libro rink and it appeared to be moving towards the Shaheen Rink. At the time of the soil testing there was no shifting or movement of the walls supported by the footings. Since the ice was removed from both rinks in April the heaving has predominantly subsided and the slab has mostly returned to its original position. Haddad Morgan noted in their review all heaving seems to be in-line with the refrigeration lines suggesting freezing of the sub surface soils. CT Soils found low

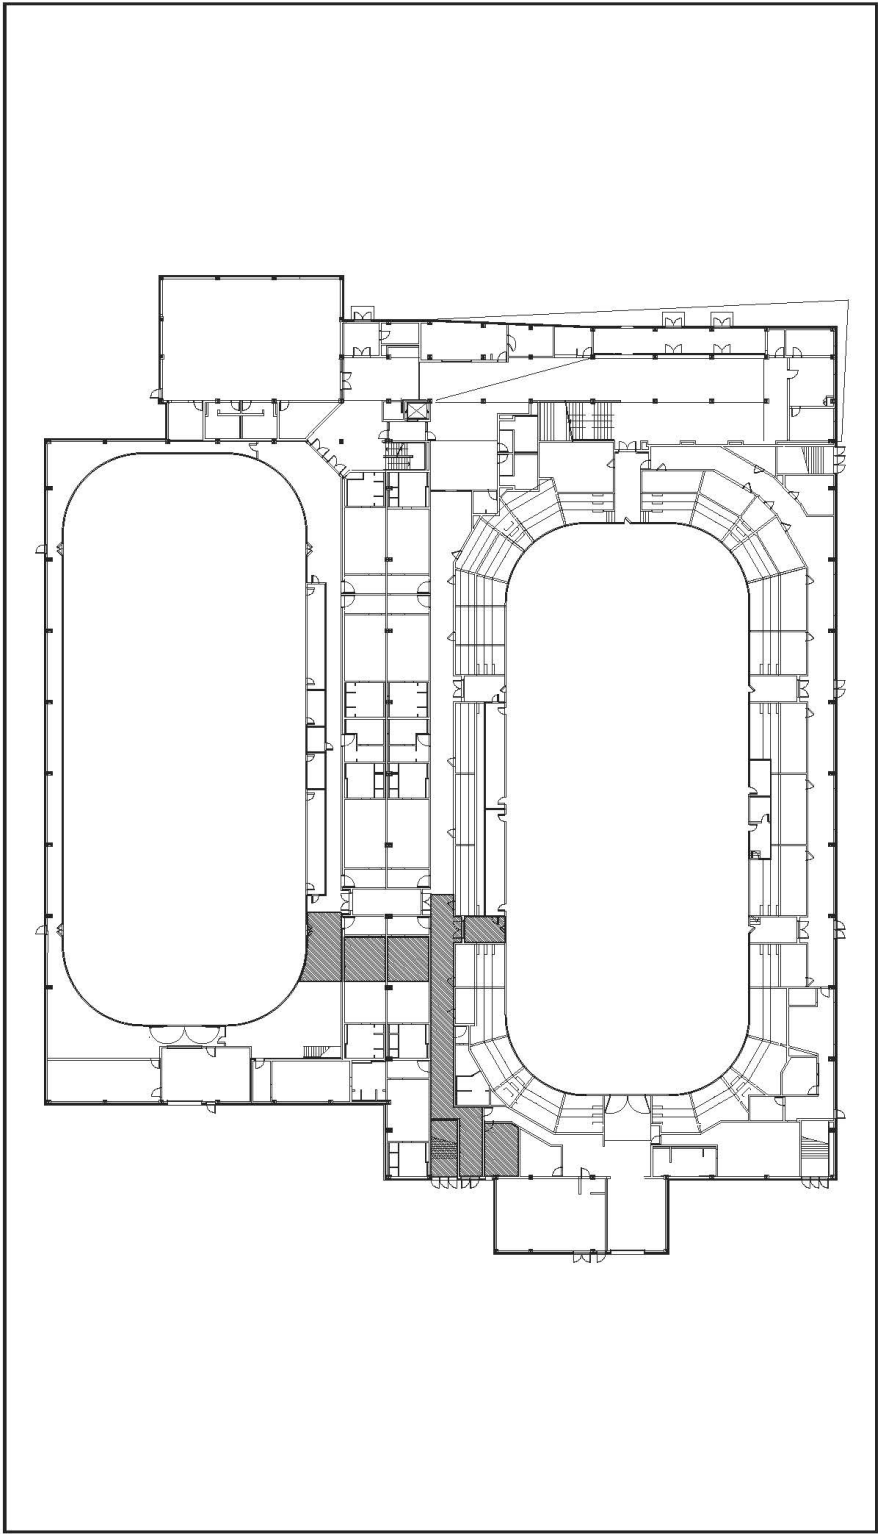
PROJECT		DATE		19-A160	
ESSEX ARENA INVESTIGATION		FIGURE 1		HADDAD, MORGAN AND ASSOCIATES LTD.	
DATE		DATE		CONSULTING ENGINEERS	
DATE		DATE		WINDSOR	
DATE		DATE		ON/AND	
DATE		DATE		FIG 1

Referring to Attached Figure 1, heaving of the slab was initially noted in the main corridor, this area was expanded to include the mechanical room after cracks and heaving were identified in this location. Additional crack was noted in the stairwell from the main rink bowl to the exterior but at that time its relationship to the other heaving issues was undetermined.

Having reviewed the design drawings for the refrigeration system it was noted that all observed heaving was in line with the refrigeration lines suggesting freezing of the sub surface soils causing the observed effect. As such C.T. Soil's was engaged to carry out a soils assessment to correlate the relationship of all observations and check for potential frozen soil affects.

C.T. Soils found (refer to attached report) low temperatures in the soil at the levels around the pipe. Soils below the pipe layer were also noted as being frozen which would cause the noted heaving condition. The report does note that the soils are saturated at depth of approximately 1.5 to 1.6m which would place these soils under the footing level of the building.

It is therefore recommended, based on the C.T. Soil's investigation that the frost susceptible soils to underside of footing be removed (point 1 above), and a drainage system be introduced along the pipes to remove excess water (point 3 above). Finally, insulation is to be placed under the pipe and extended for 1200mm (4'-0) past the pipe, or the equivalent thereof, under the pipes (point 2 above) to reduce if not eliminate movement of the cold downward.
